Utzon Room

Building Name	Utzon Room (<i>formerly Reception Hall</i>)
Location	Sydney Opera House, Bennelong Point, Sydney
Owner/client	Sydney Opera House Trust/Sydney Opera House Building Development Group
Architects	Utzon Architects (Jørn and Jan Utzon) and Johnson Pilton Walker (JPW) (Richard Johnson)
Project Cost	\$4.6m including restoration work, tapestry and wheelchair lift
Builder	Hansen Yuncken
Heritage Architect	Trevor Waters
Project Manager	CGP Management
Heritage Impact Statement	James Semple Kerr
Structural, Acoustic and Fire Engineering	Arup Structural, Arup Acoustic, Arup Fire
Quantity Surveyor	Rider Hunt Sydney
Concrete Restoration	Lucas Stuart (specialist restoration of concrete beams and walls)
Tapestry	Jørn Utzon, <i>Homage to Carl Philip Emmanuel Bach</i> . (Wool and cotton, woven by the Victorian Tapestry Workshop, July 2004). Lin Utzon (Jørn's daughter) supervised the creation of the tapestry.

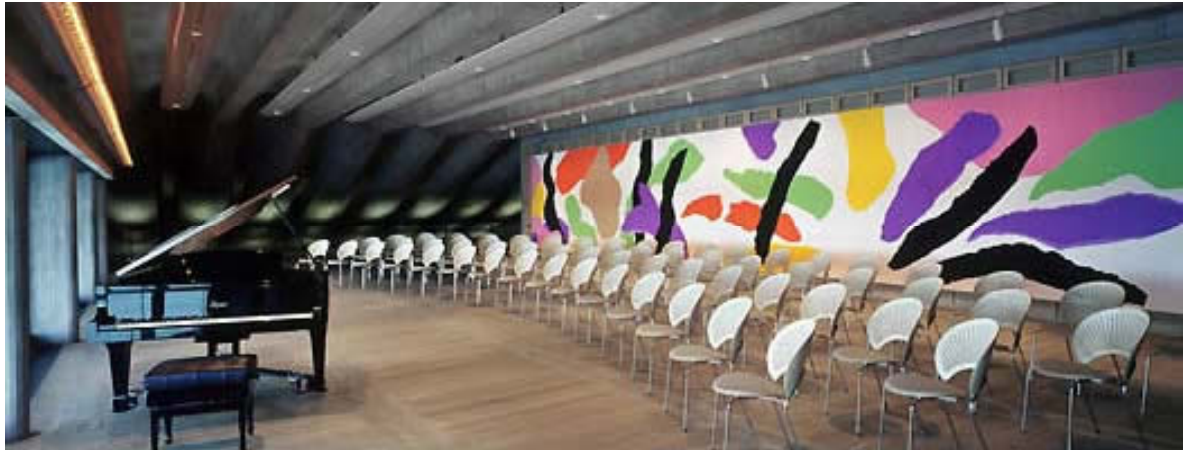
The Utzon Room tapestry and Trinidad chairs (Source <http://www.jpw.com.au/interiors.htm>)

The Utzon Room, the newly refurbished former Reception Hall, is accessed by climbing the steps under the concourse of the Sydney Opera House and then taking a sharp right turn. The main entry, in the south west corner of the room, opens out unexpectedly to reveal a long, well-lit space lined in pale timber and concrete (on floor and ceiling respectively) with colour provided by a long tapestry opposite the windows.

It is well known that Utzon had a special fondness for this room. Large east-facing windows allow light to penetrate and illuminate the floor, ceiling and wall-to-floor tapestry on the opposite wall (which conceals an acoustic chamber). The view is down the harbour seaward but does include Mrs Macquarie's Chair, over the end of the Domain and Farm Cove. The natural light provides an exceptional quality to this room and this is greatly enhanced by the tapestry colours and by the soft, neutral lustre of the floor and wall timbers. The general light fixtures are similar to those used in Utzon's Bagsværd Church in Copenhagen (built in 1976). The softer light

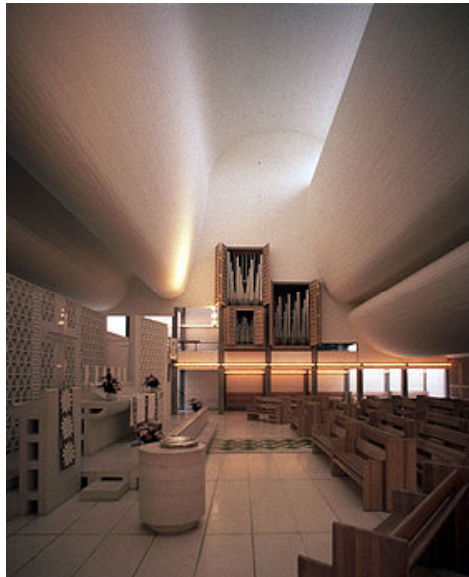
Ceiling and light treatment in Utzon's Bagsværd Church in Copenhagen (built in 1976) (Source <http://www.utzon.dk/?acc=64>)

The folded concrete beams, also reminiscent of that in the Bagsværd Church, appear to hover lightly overhead and then drop to the floor, for structural and acoustic purposes, at the southern end. This effect of weightlessness is achieved through the milky white colouring of the folds (hand-rubbed to achieve a white and clearer pigmentation to replicate Utzon's original design) and the use of suspended strip lighting between the folds (the housing of which also contain the Room's other AV services).

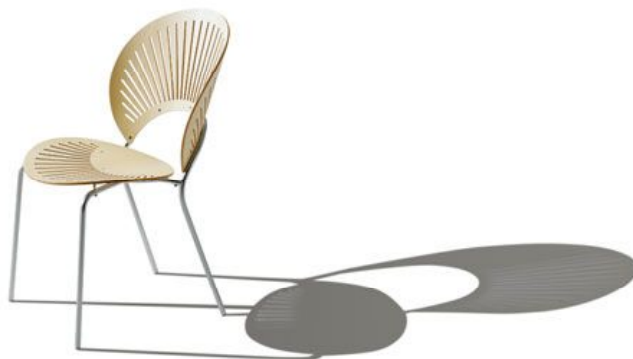
Trinidad Chair by Nanna Ditzel (manufactured by Fredericia Furniture), which won the 1995 ID Prize, and which is also cleaned using soap flakes dissolved in hot water. (Source: <http://www.fredericia.com/>)
